# An Investigation of the Therac-25 Accidents

Nancy G. Leveson, University of Washington

Clark S. Turner, University of California, Irvine

**A thorough account of the Therac-25 medical electron accelerator accidents reveals previously unknown details and suggests ways to reduce risk in the future.**

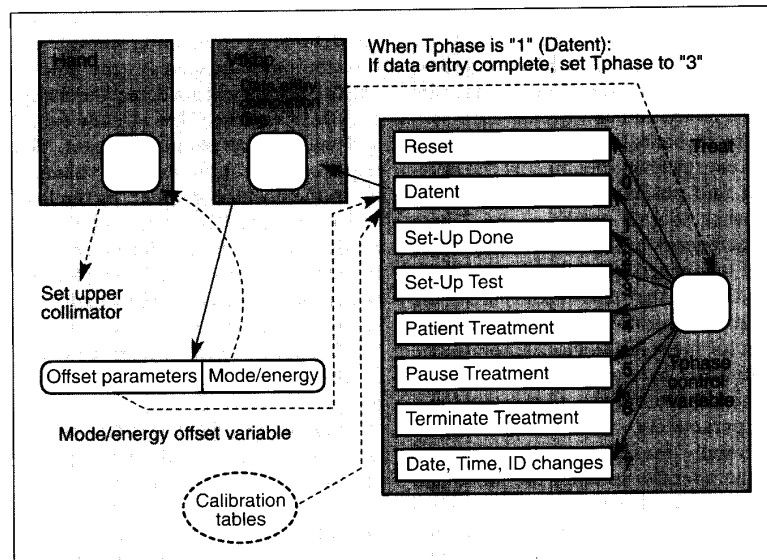
Figure 2. Tasks and subroutines in the code blamed for the Tyler accidents.

As described in the sidebar on Therac-25 software development and design, the treatment monitor task (Treat) controls the various phases of treatment by executing its eight subroutines (see Figure 2). The treatment phase indicator variable (Tphase) is used to determine which subroutine should be executed. Following the execution of a particular subroutine, Treat reschedules itself.

One of Treat's subroutines, called Datent (data entry), communicates with the keyboard handler task (a task that runs concurrently with Treat) via a

shared variable (Data-entry completion flag) to determine whether the prescription data has been entered. The keyboard handler recognizes the completion of data entry and changes the Data-entry completion variable to denote this. Once the Data-entry completion variable is set, the Datent subroutine detects the variable's change in status and changes the value of Tphase from 1 (Data Entry) to 3 (Set-Up Test). In this case, the Datent subroutine exits back to the Treat subroutine, which will reschedule itself and begin execution of the Set-Up Test subroutine. If the Data-entry completion variable has not been set, Datent leaves the value of Tphase unchanged and exits back to Treat's main line. Treat will then reschedule itself, essentially rescheduling the Datent subroutine.

Upon exit from the Magnet subroutine, the data-entry subroutine (Datent) checks the data-entry completion variable. If it indicates that data entry is complete, Datent sets Tphase to 3 and Datent is not entered again. If it is not set, Datent leaves Tphase unchanged, which means it will eventually be re-scheduled. But the data-entry completion variable only indicates that the cursor has been down to the command line, not that it is still there. A potential race condition is set up. To fix this, AECL introduced another shared variable controlled by the keyboard handler task that indicates the cursor is not positioned on the command line. If this variable is set, then prescription entry is still in progress and the value of Tphase is left unchanged.
