# An Investigation of the Therac-25 Accidents

Nancy G. Leveson, University of Washington

Clark S. Turner, University of California, Irvine

**A thorough account of the Therac-25 medical electron accelerator accidents reveals previously unknown details and suggests ways to reduce risk in the future.**

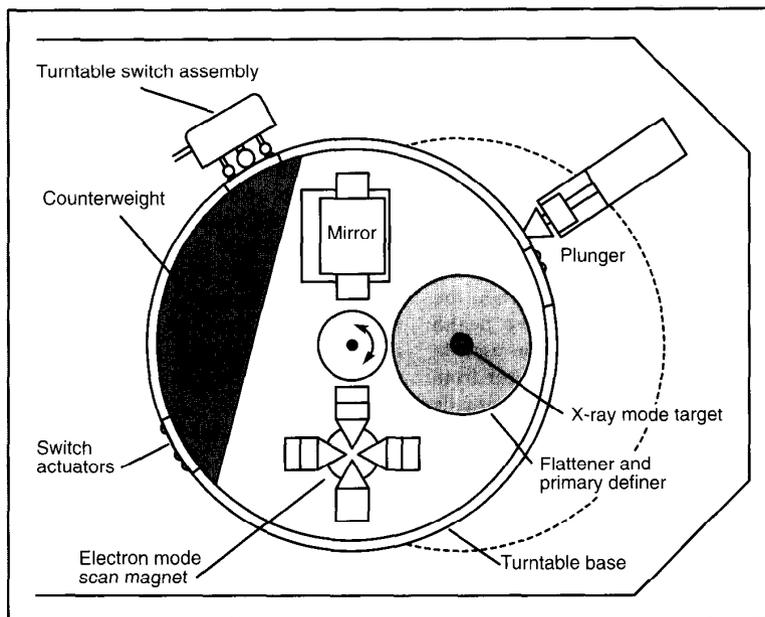
Figure B. Upper turntable assembly.

hazard of dual-mode machines: If the turntable is in the wrong position, the beam flattener will not be in place.

No accelerator beam is expected in the field-light position. A stainless steel mirror is placed in the beam path and a light simulates the beam. This lets the operator see precisely where the beam will strike the patient and make necessary adjustments before treatment starts. There is no ion chamber in place at this turntable position, since no beam is expected.

cate turntable position that tolerated a 1-bit error: The code would still unambiguously reveal correct position with any one microswitch failure.

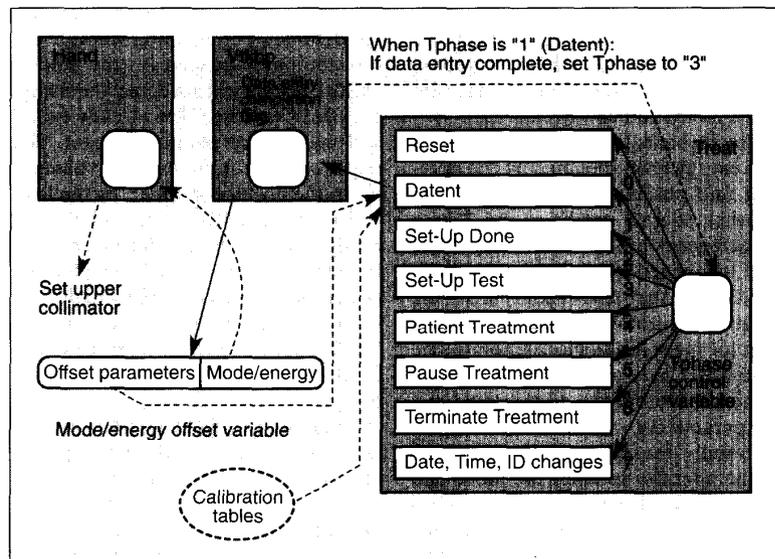
**Figure 2.** Tasks and subroutines in the code blamed for the Tyler accidents.

One of Treat's subroutines, called Datent (data entry), communicates with the keyboard handler task (a task that runs concurrently with Treat) via a

shared variable (Data-entry completion flag) to determine whether the prescription data has been entered. The keyboard handler recognizes the completion of data entry and changes the Data-entry completion variable to denote this. Once the Data-entry completion variable is set, the Datent subroutine detects the variable's change in status and changes the value of Tphase from 1 (Data Entry) to 3 (Set-Up Test). In this case, the Datent subroutine exits back to the Treat subroutine, which will reschedule itself and begin execution of the Set-Up Test subroutine. If the Data-entry completion variable has not been set, Datent leaves the value of Tphase unchanged and exits back to Treat's main line. Treat will then reschedule itself, essentially rescheduling the Datent subroutine.

Upon exit from the Magnet subroutine, the data-entry subroutine (Datent) checks the data-entry completion variable. If it indicates that data entry is complete, Datent sets Tphase to 3 and Datent is not entered again. If it is not set, Datent leaves Tphase unchanged, which means it will eventually be re-scheduled. But the data-entry completion variable only indicates that the cursor has been down to the command line, not that it is still there. A potential race condition is set up. To fix this, AECL introduced another shared variable controlled by the keyboard handler task that indicates the cursor is not positioned on the command line. If this variable is set, then prescription entry is still in progress and the value of Tphase is left unchanged.

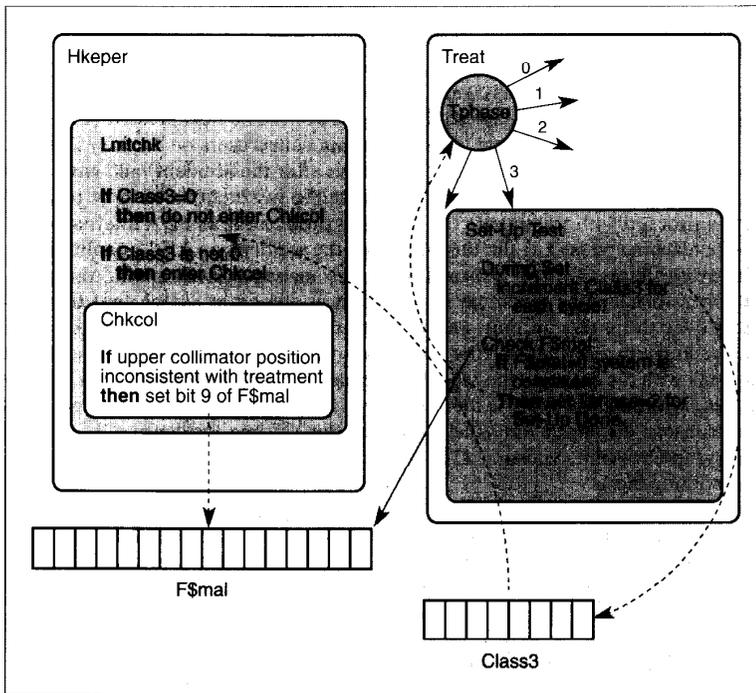
Figure 4. Yakima software flaw.

The second Yakima accident was again attributed to a type of race condition in the software — this one allowed the device to be activated in an error setting (a "failure" of a software interlock). The Tyler accidents were related to prob-

blems in the data-entry routines that allowed the code to proceed to Set-Up Test before the full prescription had been entered and acted upon. The Yakima accident involves problems encountered later in the logic after the treatment monitor Treat reaches Set-Up Test.
